# Rail Safety Advisory 617-05/19

Air brake system inspection and maintenance on grain hopper cars used in CP unit train operation

11 April 2019

617-05-19  
R19C0015

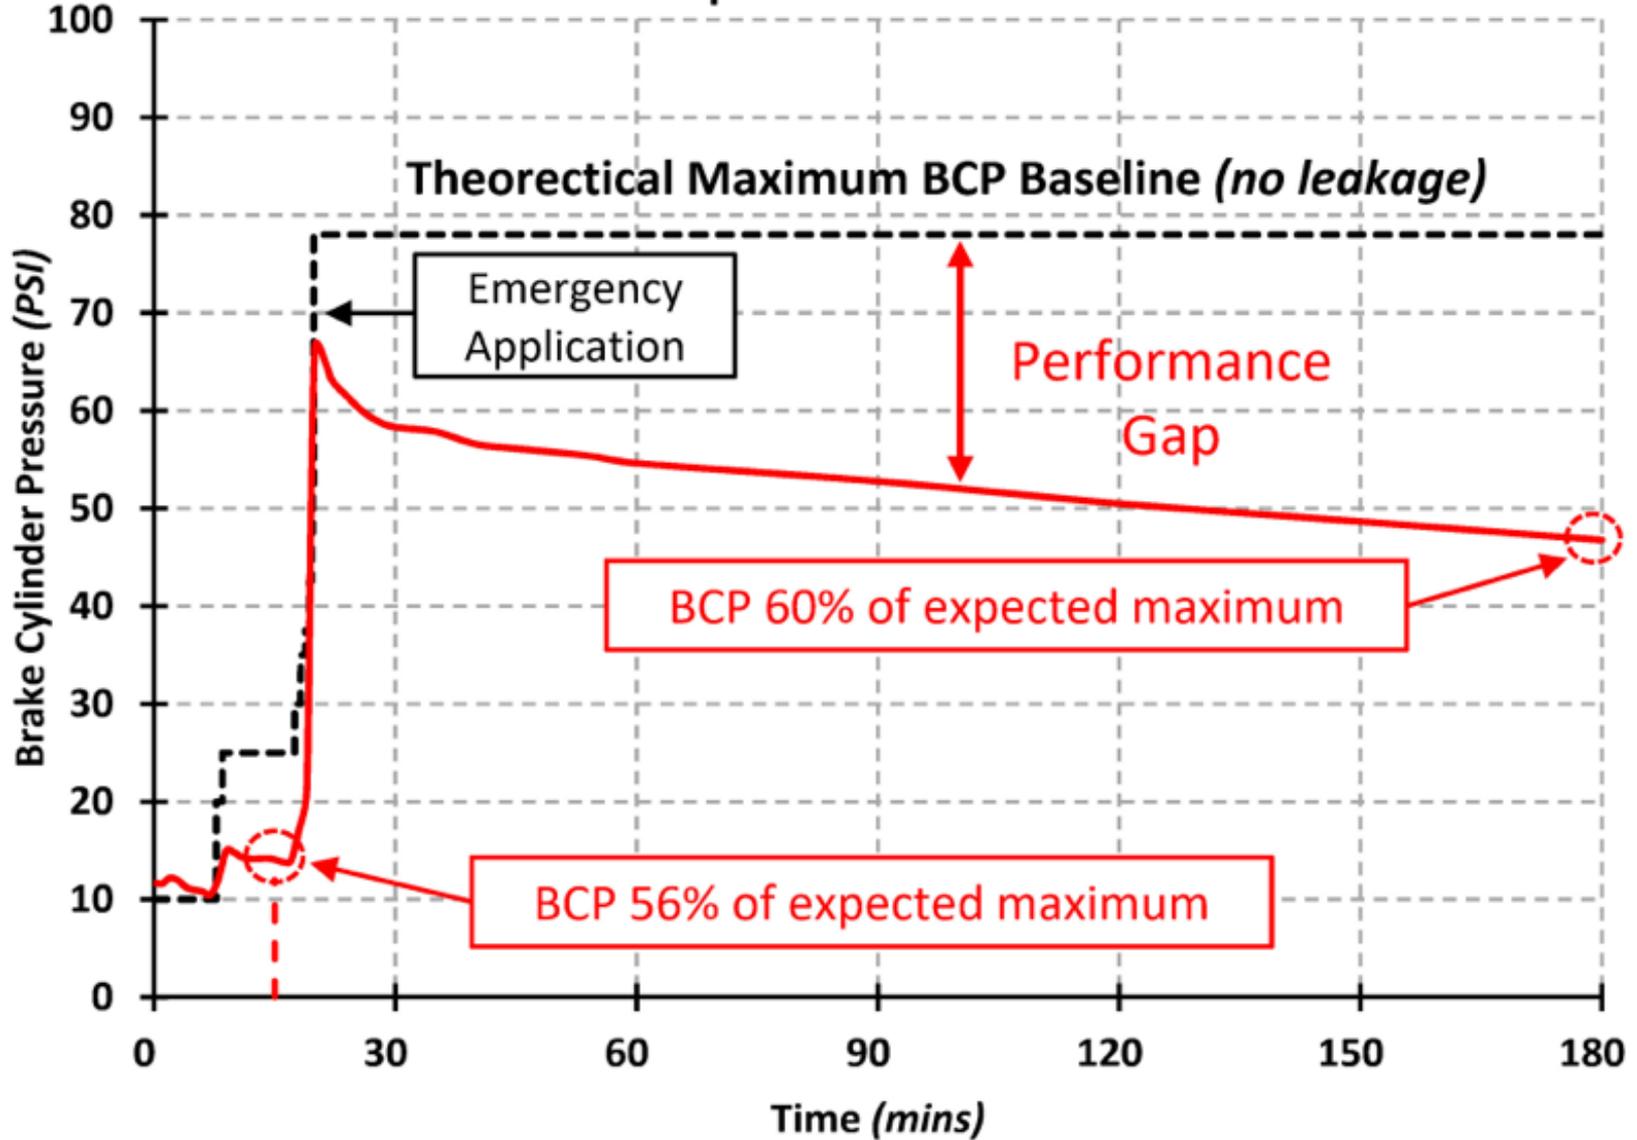
Brake cylinder leakage test (08-Feb-2019) - Aggregate pressure for all 13 cars - Temperature -19°C to -21°C

applied for an extended duration, such as while descending a steep grade. Annex A provides a summary of the test results, including a graph of the measured brake cylinder pressure (BCP) leakage (i.e., average BCP of the 13 cars plotted over the 3-hour test period).

- Relative to the expected maximum pressure during the series of service brake applications, BCP dropped to 56% in 15 minutes.
- Relative to the expected maximum pressure from the emergency brake application, BCP dropped to 60% at the end of the 3-hour test period.

The following summary graph presents aggregated BCP test results. From the test measurements, the average BCP for the 13 hopper cars was calculated and plotted (in red) over a 3-hour timeframe. As reference, the expected theoretical maximum BCP baseline is shown as a dashed line.

relief will help restore air brake efficiency. However, given the potential consequences when uncontrolled movements occur, particularly in mountain territory, Transport Canada may wish to review the efficacy of the inspection and maintenance procedures for grain hopper cars used in CP's unit grain train operations (and for other railways as applicable), and ensure that these cars can be operated safely at all times.
